HOSKINS-WESTERN-SONDEREGGER INC LINCOLN NE
NATIONAL DAM SAFETY PROGRAM. NODAWAY LAKE DAM (MO 10178) LOWER --ETC(U)
AUG 78 H P HOSKINS

PHASE I INSPECTION OF
NATIONAL DAM SAFETY PROGRAM

FINAL REPORT

PHASE I REPORT
NATIONAL DAM SAFETY PROGRAM

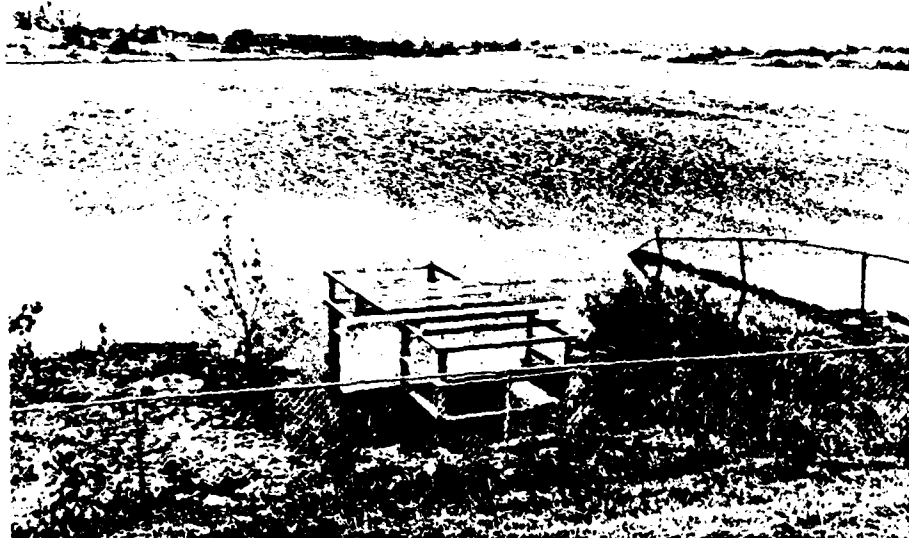
(1) Principal Spillway - There were no indications of spalling or deterioration of the principal spillway riser nor the concrete pipe outlet. The lake level was at the spillway crest elevation at the time of the inspection.

PHOTO NO. 6
PRINCIPAL SPILLWAY
FROM ABOUT
STA. 7+60

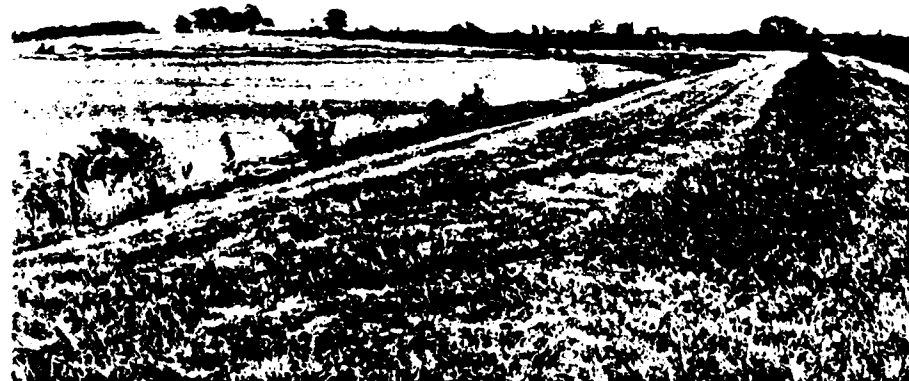
PHOTO NO. 7
LOOKING EAST
FROM WEST END
OF DAM

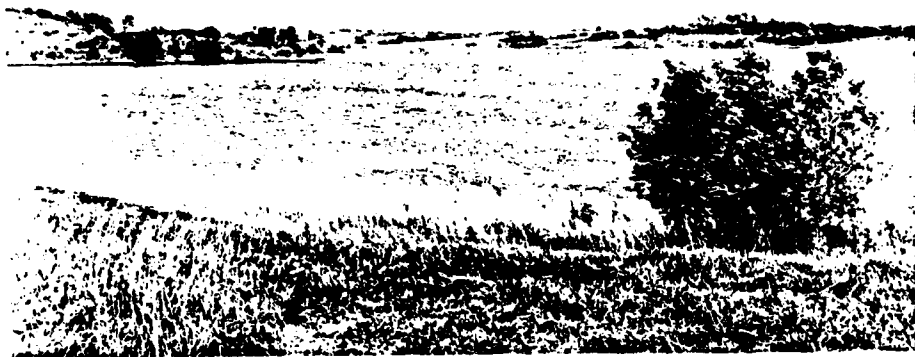
d. Reservoir Area. No wave wash, excessive erosion or slides were observed along the shore of the reservoir. The east shoreline was riprapped for a distance of 1200 to 1300 feet upstream from the dam.

PHOTO NO. 8
LOOKING NORTH
ACROSS RESERVOIR
FROM WEST END
OF DAM

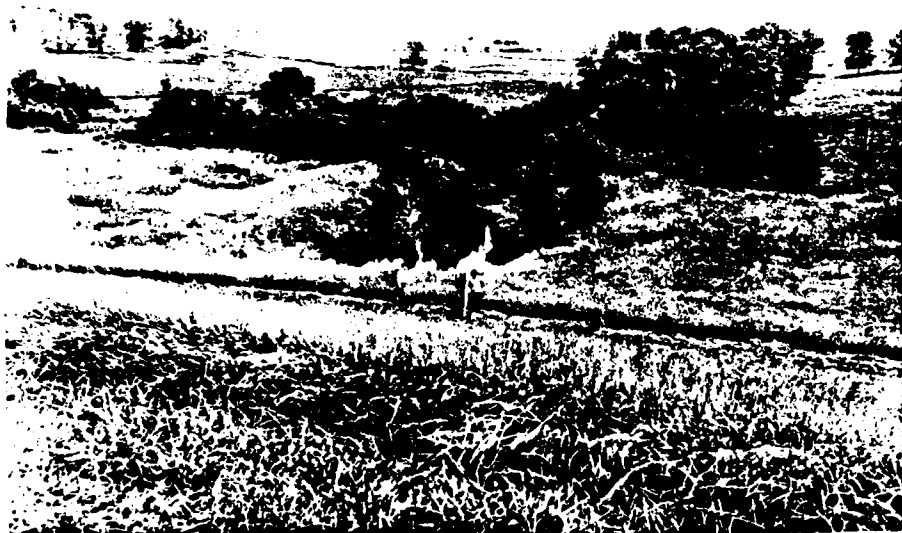
(e) Downstream channel - badly blocked with trees and brush which could affect tailwater conditions on principal spillway discharge.

PHOTO NO. 9
LOOKING AT
DOWNSTREAM CHANNEL
FROM TOP OF DAM

(3) The affects of the tree clogged channel downstream from the principal spillway upon tailwater elevations in the plunge pool are not known. The downstream channel should be cleared of trees and brush and measures initiated to prevent recurrence of growth.

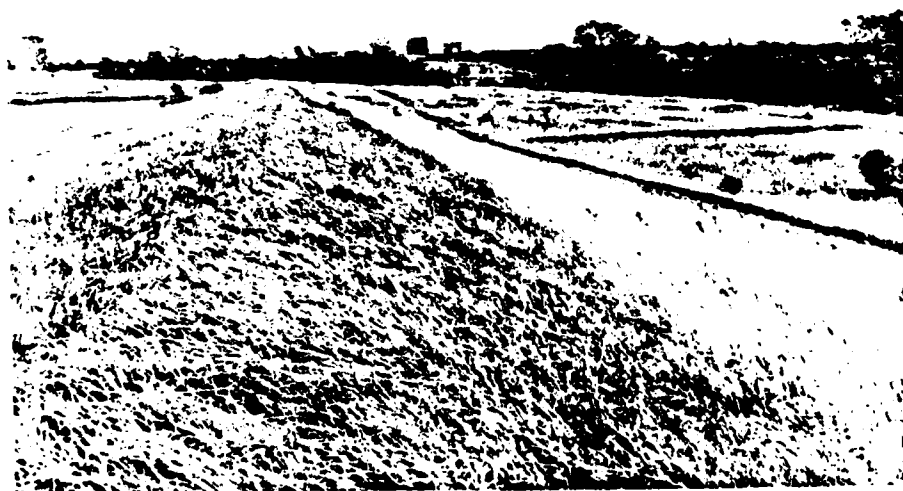
No cracks, slides, or abnormal deformations were observed in the embankment.

PHOTO NO. 10
DOWNSTREAM SLOPE
FROM STA. 3+00
TO EAST
